**Flood Control Project Maintenance
Levee Inspections**

Fall 2016 Levee Maintenance Deficiency Summary Report

Reclamation District No. 1500 Sutter Basin

Fall 2016 Levee Inspection Results

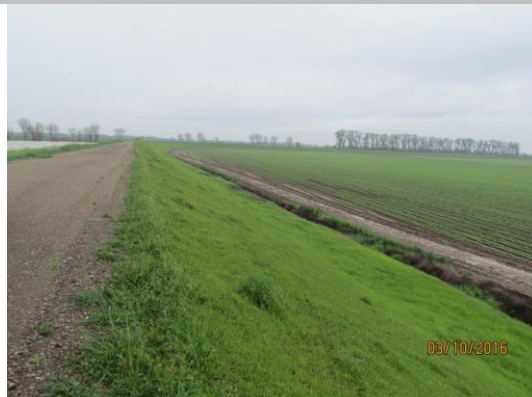
Photo 1 of 1 : FA_2016_RD1500_189_38_20160913_00032.jpg

LM Start	28.23	Rating **	M	Issue No.	38
LM End	29.23	Issue Type +	En	Location *	LS
Category	Earthen Levee			GPS Latitude/Longitude	
				Start	End
Item	Encroachments			38.983119 °	38.988538 °
				-121.819923 °	-121.806445 °
DWR ID	DWR_RD1500_01_s_2012_38				
Comment Code					
DT : Ditch					
Inspector Comment

View of the ditch on the landward side of the levee looking upstream.
Spring 2016.

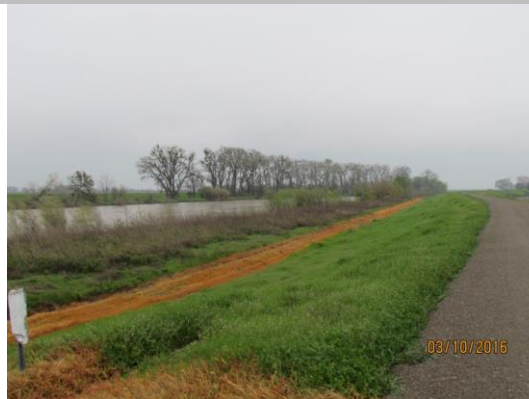
Photo 1 of 2 : FA_2016_RD1500_189_84_20160913_00050.jpg

LM Start	28.94	Rating **	A/W	Issue No.	84
LM End	29.17	Issue Type +	Ma	Location *	WS
Category	Earthen Levee			GPS Latitude/Longitude	
				Start	End
Item	Vegetation			38.988072 °	38.988572 °
				-121.811737 °	-121.807520 °
DWR ID	DWR_RD1500_01_s_2012_84				
Comment Code					
V8 : Environmental Requirements.					
Inspector Comment

View of the revegetation site on the waterward side of the levee looking upstream. Spring 2016.

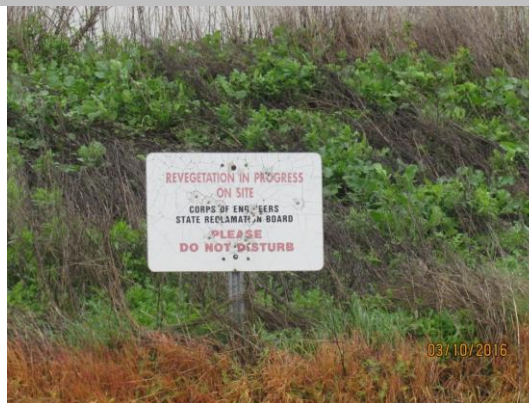
Photo 2 of 2 : FA_2016_RD1500_189_84_20160913_00051.jpg

Sign for the revegetation site. Spring 2016.

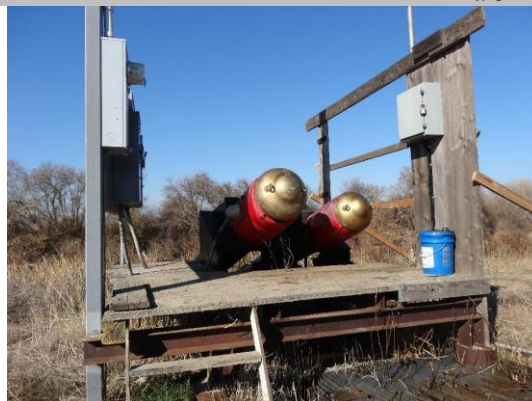
Photo 1 of 2 : UCIP_FA_2016_50194_51834.jpg

FS_ID:50194
DS_ID:20113
EP_NO: 10054
Repair Type: Non-Urgent
Crossing Status: Found
UCIP Comments: 08/29/2016: Found no evidence of leakage or subsidence. CMP risers are both silted in and need lids. Need a name change permit for new owner Brad Howalt. Possible sink hole in alignment with pipes on crown has been covered with concrete. Crossing has been downgraded from Urgent to Non-Urgent. (K. Fazel - UCIP)01/15/2014:Levee slope erosion due to leakage from siphon breaker. Water leaking from pipe near distribution box on landside levee toe. Overhead powerline. (P. Amatya - DWR)
FIELD_STRUCT_DESC: 2 of 2: 16-inch steel irrigation pipe through the levee, 5 feet below the crown. Siphon breaker in a 24-inch corrugated metal (CM) riser on the landside (LS) shoulder. Another 20-inch steel irrigation pipe through the levee at this location, 5 feet below the crown. Another siphon breaker in a 24-inch CM riser on the LS shoulder. Slant pumps in a CM pump house mounted on a steel pile structure on the berm. 4-foot by 7-foot concrete inspection box for a Hersey-Sparling water meter on the berm in front of the pump house. Flap gates in a 9.7-foot by 10.6-foot (outside dimensions) concrete distribution box at the LS toe. (Automatic Board Order (ABO) issued as Permit No. 10054, 1974 - Lerner). [Additional Reference(s): DWR Levee Log, 2005. USACE Sacramento O&M Manual 128, March 1960 (HLM 30.29)].

WS view: two slant pumps on wooden platform on levee berm.

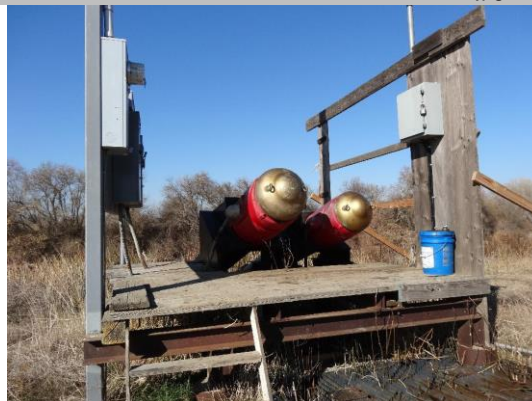
Photo 1 of 2 : UCIP_FA_2016_50201_52855.jpg

FS_ID:50201
DS_ID:20084
EP_NO: 10054
Repair Type: Non-Urgent
Crossing Status: Found
UCIP Comments: 08/29/2016: Found no evidence of leakage or subsidence. CMP risers are both silted in and need lids. Need a name change permit for new owner Brad Howalt. Possible sink hole in alignment with pipes on crown has been covered with concrete. Crossing has been downgraded from Urgent to Non-Urgent. (K. Fazel - UCIP)01/15/2014:Levee slope erosion due to leakage from siphon breaker.Water leaking from pipe near distribution box on landside levee toe.Overhead powerline. (P. Amatya - DWR)
FIELD_STRUCT_DESC: 1 of 2: 20-inch steel irrigation pipe through the levee, 5 feet below the crown. Siphon breaker in a 24-inch corrugated metal (CM) riser on the landside (LS) shoulder. Another 16-inch steel irrigation pipe through the levee at this location, 5 feet below the crown. Another siphon breaker in a 24-inch CM riser on the LS shoulder. Slant pumps in a CM pump house mounted on a steel pile structure on the berm. 4-foot by 7-foot concrete inspection box for a Hersey-Sparling water meter on the berm in front of the pump house. Flap gates in a 9.7-foot by 10.6-foot (outside dimensions) concrete distribution box at the LS toe. (Automatic Board Order (ABO) issued as Permit No. 10054, 1974 - Larner). [Additional Reference(s): DWR Levee Log, 2005. USACE Sacramento O&M Manual 128, March 1960 (HLM 30.29)].

WS view: slant pumps and control boxes on steel platform at levee berm.

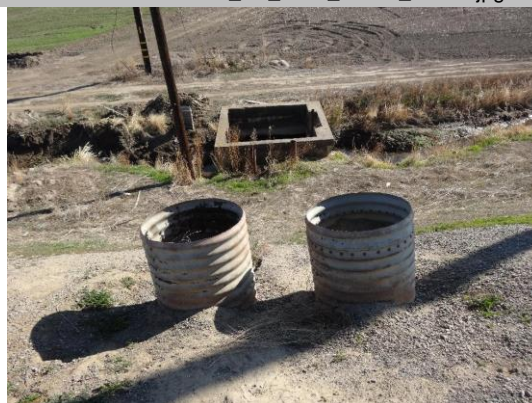
Photo 2 of 2 : UCIP_FA_2016_50201_52854.jpg

LS view: siphon breakers in CMP riser on levee slope and distribution box on levee toe.

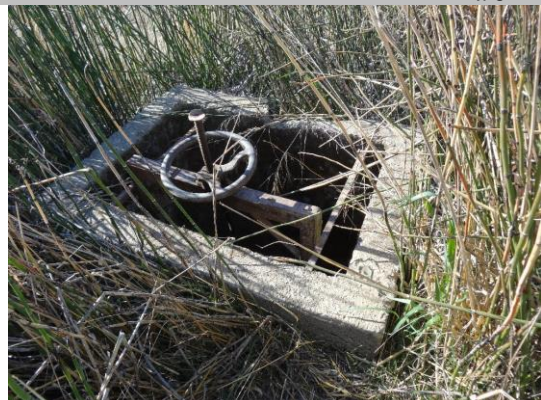
Photo 2 of 2 : UCIP_FA_2016_50193_51826.jpg

Comment Code					
Inspector Comment					
FS_ID:50193 DS_ID:20107 EP_NO: 6169 Repair Type: Non-Urgent Crossing Status: Found UCIP Comments: 08/29/2016: Pipe and pump are leaking oil. Could not find evidence of any water leak. Field hand may have spilled oil as there is a puddle of oil beneath the pump. Crossing downgraded from Urgent to Non-Urgent. (K. Fazel - UCIP)01/15/2014: Leaky pump and excessive vegetation observed along pipe alignment on waterside slope of the levee. It needs more investigations. May have new permit for slant pump. (P. Amatya - DWR) FIELD_STRUCT_DESC: 30-inch reinforced concrete-encased steel irrigation pipe through the levee, 15.5 feet below the crown. Slant pump and switch panel on steel pile structure at edge of the berm. Slide gate in a 2.5-foot by 3.5-foot (inside dimensions) concrete box on the berm. 6-foot by 8-foot concrete distribution box at the landside (LS) toe. 2-inch conduit through the levee, 2.5 feet below the crown. (Permit No. 6169, 1968 - Butler). Pipe through levee was initially installed in 1952. [Additional Reference(s): DWR Levee Log, 2002. USACE Sacramento O&M Manual 128, March 1960 (HLM 30.46)]. FS Date: 8/29/2016

WS view: concrete surge box with slide gate on levee berm.

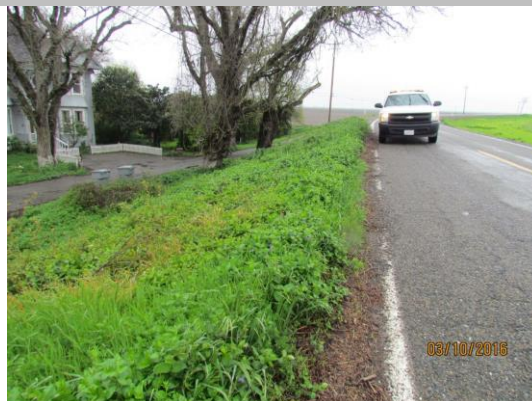
Photo 1 of 1 : FA_2016_RD1500_189_45_20160913_00034.jpg

LM Start	30.22	Rating **	M	Issue No.	45
LM End	30.22	Issue Type +	En	Location *	LS
Category	Earthen Levee			GPS Latitude/Longitude	
				Start	End
Item	Vegetation			38.997027 °	38.997027 °
				-121.794755 °	-121.794755 °
DWR ID	DWR_RD1500_01_s_2012_45				
Comment Code					
V6 : Landscaping					
Inspector Comment

View of the groundcover on the landward side of the levee looking downstream. Spring 2016.

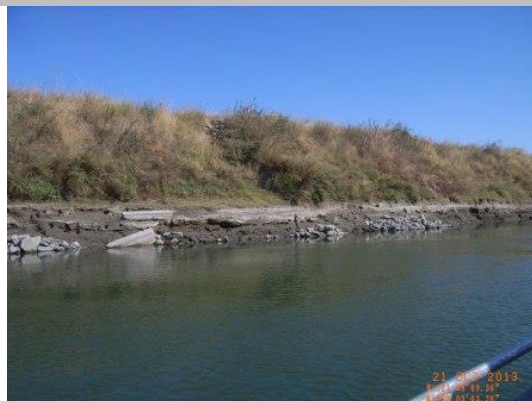
Photo 1 of 1 : FA_2016_RD1500_189_22_20160913_00019.jpg

LM Start	30.60	Rating **	A/W	Issue No.	22
LM End	30.75	Issue Type +	Ma	Location *	WS
Category	Supplemental			GPS Latitude/Longitude	
				Start	End
Item	2015 USACE Erosion Survey, DRAFT			38.999745 °	39.001413 °
				-121.800898 °	-121.802889 °
DWR ID	DWR_RD1500_01_s_2016_22				
Comment Code					
Inspector Comment					
2000 - Eroding, vertical berm slope over a vertical cohesive toe; slow erosion but getting close to the toe. 2002 - Erosion is getting close to the levee, still eroding with some new small slumps. 2004 - Some minor new erosion. 2006 - Some new erosion, cleaned off older scars and slump faces. 2008 - New, small, partial rotational failure. 2011 - Some new minor erosion. 2015: No observed changes. [2015 Site ID: SAC_116-0_L]

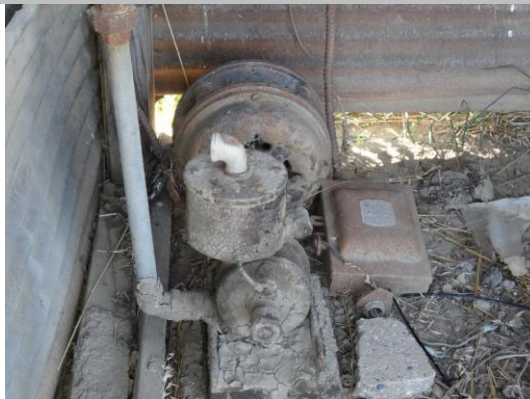
Photo 1 of 2 : UCIP_FA_2016_28144_51812.jpg

LM Start	30.87	Rating **	M	Issue No.	2582
LM End	30.87	Issue Type +	En	Location *	WS
Category	Supplemental			GPS Latitude/Longitude	
				Start	End
Item	DWR UCIP Field Study			39.002960 °	39.002960 °
				-121.803736 °	-121.803736 °
DWR ID					
Comment Code					
Inspector Comment					
FS_ID:28144					
DS_ID:20000					
EP_NO: 15916					
Repair Type: Non-Urgent					
Crossing Status: Found					
UCIP Comments: Surface erosion due to leaky pressure breaker on landside slope.					
FIELD_STRUCT_DESC: 18-inch steel irrigation pipe through levee.					
Siphon breaker in 24-inch CM riser on landward slope. Discharges into 6 foot by 8 foot I.D. concrete distribution box at landward toe. (App. No. 15916 - Butler) 18-inch replaced original 12-inch pipe (10034 - Butler)					
FS Date: 1/15/2014

WS view: pump in CM pump house on levee shoulder. Looks abandoned.

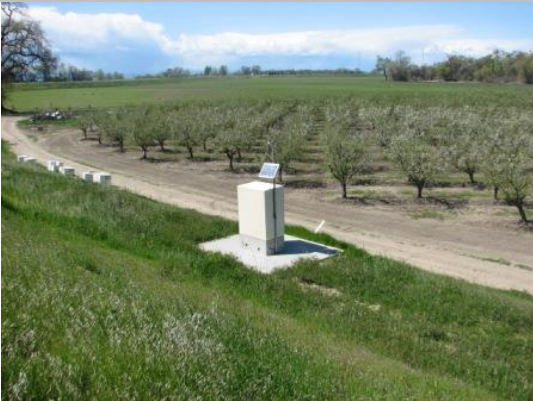
Photo 1 of 2 : FA_2016_RD1500_189_86_20160913_00052.jpg

The control unit for pizometers installed in 2012, photo taken spring 2012.

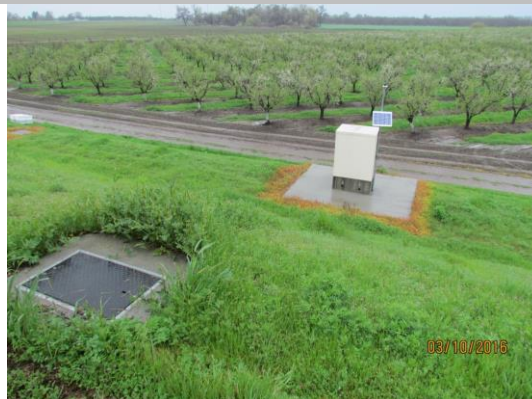
Photo 2 of 2 : FA_2016_RD1500_189_86_20160913_00053.jpg

LM Start	31.54	Rating **	A/W	Issue No.	86 (cont)	
LM End	31.54	Issue Type +	En	Location *	LS	
Category	Earthen Levee			GPS Latitude/Longitude		
				Start		End
Item	Underseepage Relief Wells			39.006687 °		39.006687 °
				-121.814967 °		-121.814967 °
DWR ID	DWR_RD1500_01_s_2016_86					
Comment Code						
Inspector Comment

View of the pizometer on the landward side of the levee. Spring 2016.

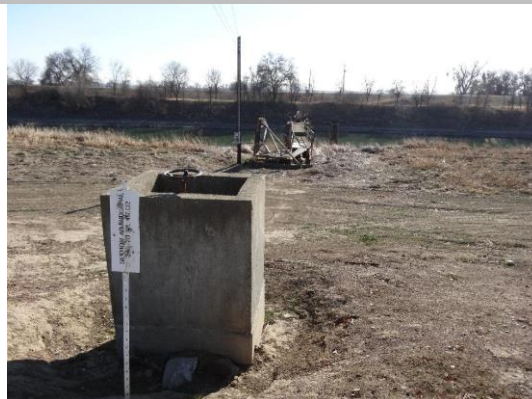
Photo 1 of 2 : UCIP_FA_2016_28143_51805.jpg

LM Start	31.61	Rating **	M	Issue No.	2581
LM End	31.61	Issue Type +	En	Location *	LS
Category	Supplemental			GPS Latitude/Longitude	
				Start	End
Item	DWR UCIP Field Study			39.006484 °	39.006484 °
				-121.816168 °	-121.816168 °
DWR ID					
Comment Code					
Inspector Comment					
FS_ID:28143 DS_ID:20077 EP_NO: 9657 Repair Type: Non-Urgent Crossing Status: Found UCIP Comments: Looks abandoned. May need proper abandonement.Overhead power line. FIELD_STRUCT_DESC: *ABANDONED* 20-inch diameter steel pipe through levee, 15.0 feet below crown. Pump on elevated structure. Slide gate in riser, concrete surge box on waterward slope. Switch panel on berm. (App. Nos. 13536 & 13941 - Niechen 10/82) Discharges into 36-inch I.D. concrete standpipe on landward side. (App. No. 9657 ABO No. 10030 - Bell) O&M Manual Sac 128, March 1960. FS Date: 1/15/2014

WS view: concrete surge box on levee slope.

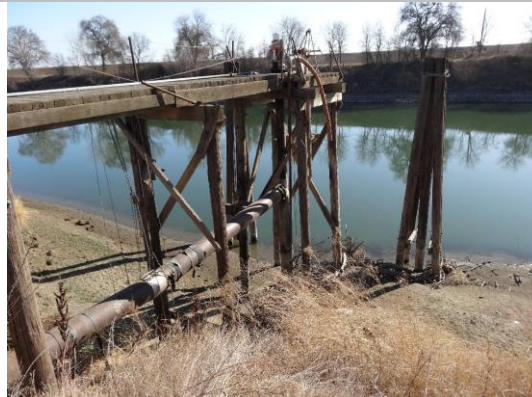
Photo 2 of 2 : UCIP_FA_2016_28143_51804.jpg

WS view: abandoned walkway, pipe, and pump on river bank.

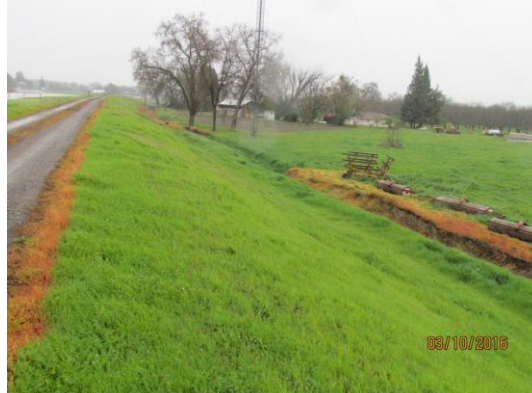
Photo 1 of 1 : FA_2016_RD1500_189_60_20160913_00041.jpg

LM Start	32.42	Rating **	M	Issue No.	60
LM End	32.57	Issue Type +	En	Location *	LS
Category	Earthen Levee			GPS Latitude/Longitude	
				Start	End
Item	Encroachments			39.013749 °	39.015620 °
				-121.825065 °	-121.823461 °
DWR ID	DWR_RD1500_01_s_ 2012_60				
Comment Code					
DT : Ditch					
Inspector Comment					
Ditch is located at the toe of the levee.

View of the ditch on the landward side of the levee looking upstream.
Spring 2016.

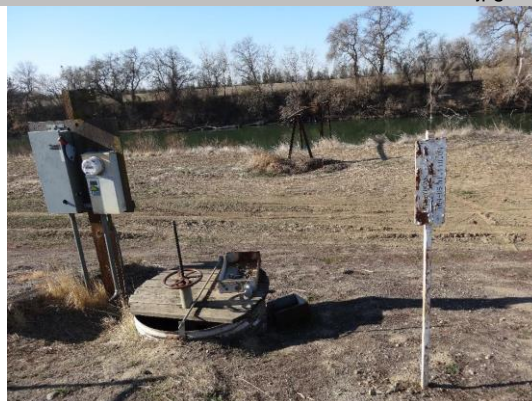
Photo 1 of 2 : UCIP_FA_2016_28943_53222.jpg

Comment Code					
Inspector Comment					
FS_ID:28943					
DS_ID:20018					
EP_NO: N/A					
Repair Type: Non-Urgent					
Crossing Status: Found					
UCIP Comments: Pipe leaks near pump through a hole in the pipe.					
Needs repair.An electric conduit through the levee. Concrete					
distribution box on landside levee toe. Slide gate in CMP on waterside					
slope.					
FIELD_STRUCT_DESC: 30-inch pipe and electric conduit through					
levee, 14.3 feet below the crown, Pump and headwall on waterside.					
Slide gate in CMP on waterside slope. Electric control box on waterside.					
Concrete distribution box on landside levee toe. O&M Manual Sac 128,					
March 1960.					
FS Date: 1/15/2014

WS view: power control panel and CMP riser with slide gate on levee slope.

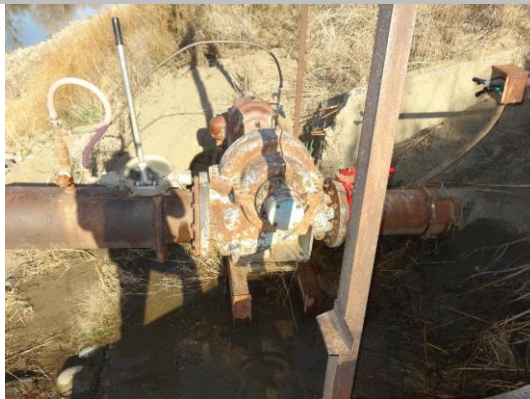
Photo 2 of 2 : UCIP_FA_2016_28943_53221.jpg

LM Start	32.55	Rating **	M	Issue No.	2578 (cont)	
LM End	32.55	Issue Type +	En	Location *	LS	
Category	Supplemental			GPS Latitude/Longitude		
				Start	End	
Item	DWR UCIP Field Study			39.015277 °	39.015277 °	
				-121.823735 °	-121.823735 °	
DWR ID						
Comment Code						
Inspector Comment						
FS_ID:28943 DS_ID:20018 EP_NO: N/A Repair Type: Non-Urgent Crossing Status: Found UCIP Comments: Pipe leaks near pump through a hole in the pipe. Needs repair.An electric conduit through the levee. Concrete distribution box on landside levee toe. Slide gate in CMP on waterside slope. FIELD_STRUCT_DESC: 30-inch pipe and electric conduit through levee, 14.3 feet below the crown, Pump and headwall on waterside. Slide gate in CMP on waterside slope. Electric control box on waterside. Concrete distribution box on landside levee toe. O&M Manual Sac 128, March 1960. FS Date: 1/15/2014

WS view: pump on river bank protected by concrete headwall. Leaky pipe near pump.

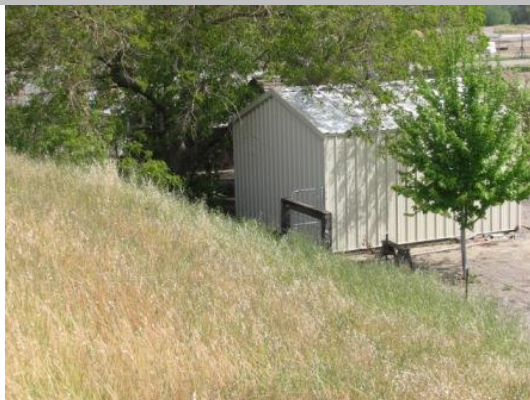
Photo 1 of 1 : FA_2016_RD1500_189_46_20160913_00035.jpg

LM Start	32.96	Rating **	M	Issue No.	46
LM End	32.96	Issue Type +	En	Location *	LS
Category	Earthen Levee			GPS Latitude/Longitude	
				Start	End
Item	Encroachments			39.020550 °	39.020550 °
				-121.820315 °	-121.820315 °
DWR ID	DWR_RD1500_01_s_2012_46				
Comment Code					
BU : Building					
Inspector Comment

The building is within the easement of the levee toe.

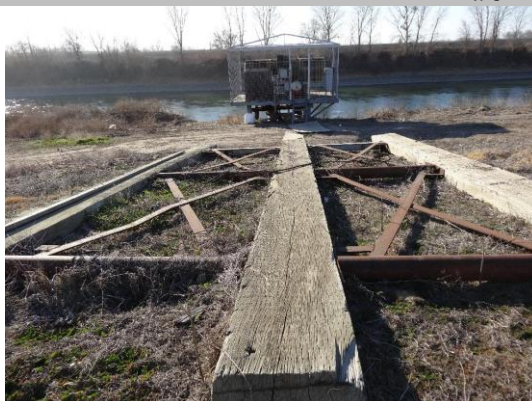
Photo 1 of 2 : UCIP_FA_2016_28953_53256.jpg

Comment Code					
Inspector Comment					
FS_ID:28953 DS_ID:20080 EP_NO: 5617 Repair Type: Non-Urgent Crossing Status: Found UCIP Comments: Not found- slide gate in 54 inch corrugated metal riser on waterside berm.Two 16-inch steel pipes (looks new). Leaky pipe near pump.Plant was working during field visit.Needs more info from LMA. There may be a new permit. FIELD_STRUCT_DESC: 1 of 2. Two 16-inch steel irrigation pipes and conduit through levee, 19.0 feet below crown. Two slant pumps on elevated pump platform on waterside. Gate valves and concrete headwall at landward berm. Meter pole at toe. Discharges into landside ditch. 1-3/4 conduit through levee. (App. No. 5617- Oji Bros.) O&M Manual Sac 128, March 1960. FS Date: 1/15/2014

WS view: slant pumps on steel platform in shed on berm.

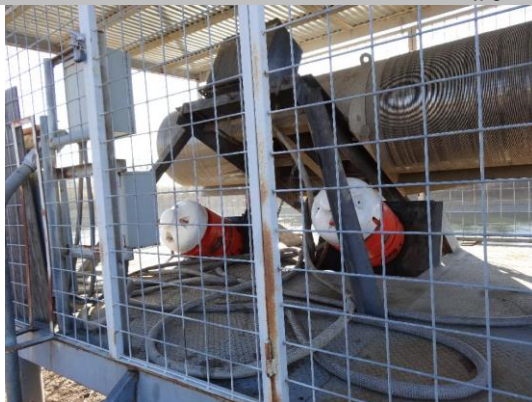
Photo 2 of 2 : UCIP_FA_2016_28953_53255.jpg

WS view: closer view of slant pumps on steel platform in shed on berm.

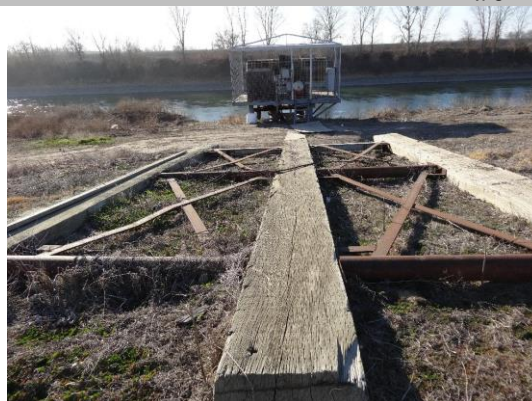
Photo 1 of 2 : UCIP_FA_2016_28952_53249.jpg

FS_ID:28952
DS_ID:24758
EP_NO: N/A
Repair Type: Non-Urgent
Crossing Status: Found
UCIP Comments: Not found- slide gate in 54 inch corrugated metal riser on waterside berm. Two 16-inch steel pipes (looks new). Leaky pipe near pump. Plant was working during field visit. Needs more info from LMA. There may be a new permit.
FIELD_STRUCT_DESC: 2 of 2. Two 16-inch steel irrigation pipe through the levee. Two slant pumps on steel platform and under the shed. Two air vents on waterside levee shoulder. Two pipes with gate valves discharge water into irrigation ditch. Service pole on landside toe. Previously only a 30-inch steel pipe through the levee and slide gate in CMP riser on waterside.
FS Date: 1/15/2014

WS view: pump platform and shed on levee berm.

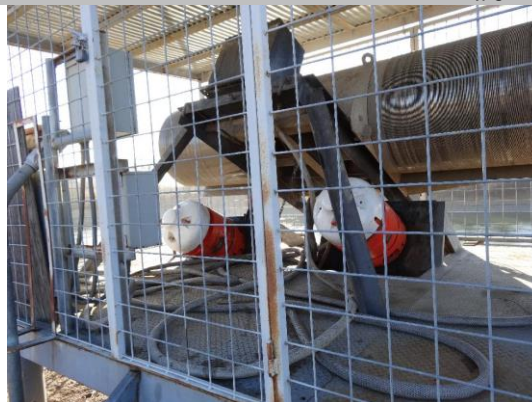
Photo 2 of 2 : UCIP_FA_2016_28952_53248.jpg

WS view: two slant pumps on steel platform at waterside berm.

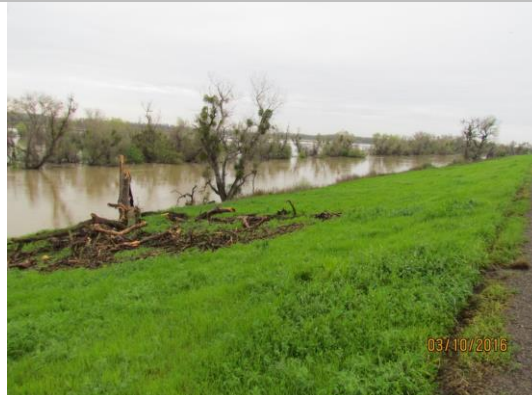
Photo 1 of 1 : FA_2016_RD1500_190_19_20160913_00009.jpg

LM Start	9.73	Rating **	M	Issue No.	19
LM End	9.73	Issue Type +	Ma	Location *	WS
Category	Earthen Levee			GPS Latitude/Longitude	
				Start	End
Item	Encroachments			38.891630 °	38.891630 °
				-121.636393 °	-121.636393 °
DWR ID	DWR_RD1500_02_s_2016_19				
Comment Code					
TR : Tree or limb					
Inspector Comment

View of the fallen tree on the waterward side of the levee looking downstream. Spring 2016.

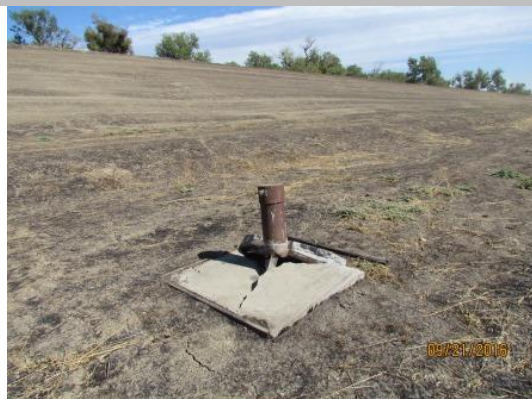
Photo 1 of 3 : FA_2016_RD1500_190_4_20160926_00012.jpg

LM Start	14.13	Rating **	U	Issue No.	4
LM End	14.13	Issue Type +	Ma	Location *	LS
Category	Earthen Levee			GPS Latitude/Longitude	
				Start	End
Item	Underseepage Relief Wells			38.947628 °	38.947628 °
				-121.669764 °	-121.669764 °
DWR ID	DWR_RD1500_02_s_2012_4				
Comment Code					
Inspector Comment					
Concrete pad and PVC underneath is broken.

View of underseepage relief well. Concrete pad as well as PVC pipes underneath are destroyed apparently by an attempt to pull out the head of the well. Fall 2016.

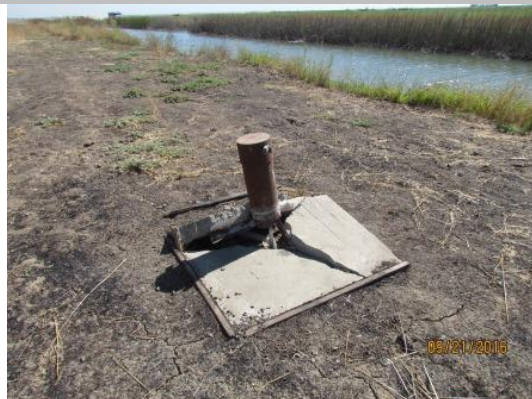
Photo 2 of 3 : FA_2016_RD1500_190_4_20160926_00011.jpg

LM Start	14.13	Rating **	U	Issue No.	4 (cont)	
LM End	14.13	Issue Type +	Ma	Location *	LS	
Category	Earthen Levee			GPS Latitude/Longitude		
				Start		End
Item	Underseepage Relief Wells			38.947628 °		38.947628 °
				-121.669764 °		-121.669764 °
DWR ID	DWR_RD1500_02_s_2012_4					
Comment Code						
Inspector Comment						
Concrete pad and PVC underneath is broken.

Another view of damaged well. Fall 2016.

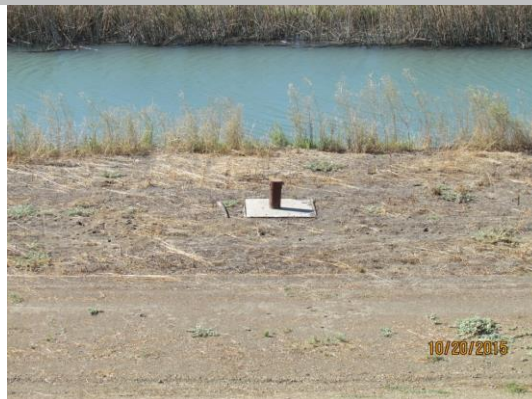
Photo 3 of 3 : FA_2016_RD1500_190_4_20160913_00001.jpg

View of the relief well at historical boil 12. Fall 2015.

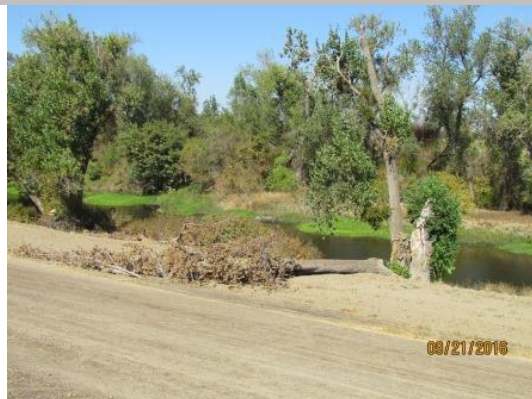
Photo 1 of 1 : FA_2016_RD1500_190_2_20160926_00013.jpg

LM Start	14.22	Rating **	M	Issue No.	2
LM End	14.22	Issue Type +	Ma	Location *	WS
Category	Earthen Levee			GPS Latitude/Longitude	
				Start	End
Item	Encroachments			38.948650 °	38.948650 °
				-121.670842 °	-121.670842 °
DWR ID	DWR_RD1500_02_f _ 2016_2				
Comment Code					
PR : Prunings					
Inspector Comment

View of WS slope of the levee. Fall 2016.

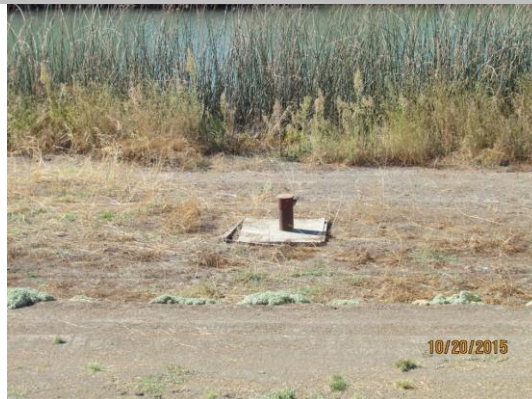
Photo 1 of 1 : FA_2016_RD1500_190_11_20160913_00004.jpg

LM Start	14.47	Rating **	A/W	Issue No.	11
LM End	14.47	Issue Type +	Ma	Location *	LS
Category	Earthen Levee			GPS Latitude/Longitude	
				Start	End
Item	Underseepage Relief Wells			38.951413 °	38.951413 °
				-121.673856 °	-121.673856 °
DWR ID	DWR_RD1500_02_s_2012_11				
Comment Code					
Inspector Comment

A relief well at historical boil 16. Fall 2015.

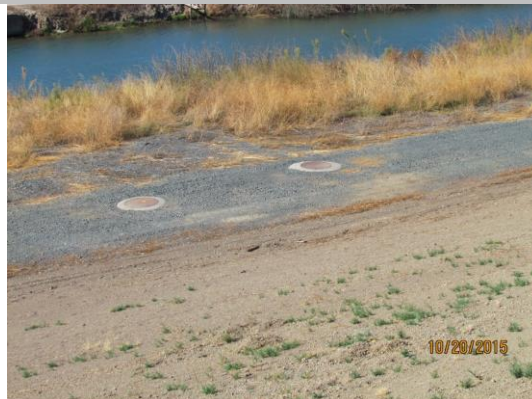
Photo 1 of 2 : FA_2016_RD1500_190_13_20160913_00006.jpg

LM Start	18.17	Rating **	A/W	Issue No.	13
LM End	18.17	Issue Type +	Ma	Location *	LS
Category	Earthen Levee			GPS Latitude/Longitude	
				Start	End
Item	Underseepage Relief Wells			38.987031 °	38.987031 °
				-121.725049 °	-121.725049 °
DWR ID	DWR_RD1500_02_s_2012_13				
Comment Code					
Inspector Comment

Two of four drains on the landward side of the levee. Fall 2015.

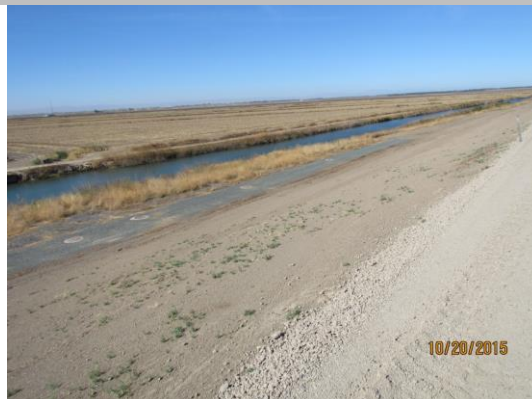
Photo 2 of 2 : FA_2016_RD1500_190_13_20160913_00007.jpg

View of the 4 drains at the levee toe on the landward side. Fall 2015.

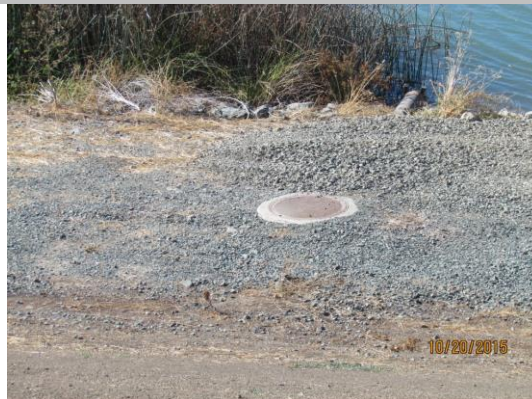
Photo 1 of 1 : FA_2016_RD1500_190_15_20160913_00008.jpg

LM Start	18.41	Rating **	A/W	Issue No.	15
LM End	18.41	Issue Type +	Ma	Location *	LS
Category	Earthen Levee			GPS Latitude/Longitude	
				Start	End
Item	Underseepage Relief Wells			38.989710 °	38.989710 °
				-121.727691 °	-121.727691 °
DWR ID	DWR_RD1500_02_s_2015_15				
Comment Code					
Inspector Comment

View of the toe drainage at the landward toe berm. Fall 2015.
